ARBORIST REPORT

**For
11406 NE 112th Street
Kirkland, WA**

**October 13th, 2014
Updated May 6, 2016**

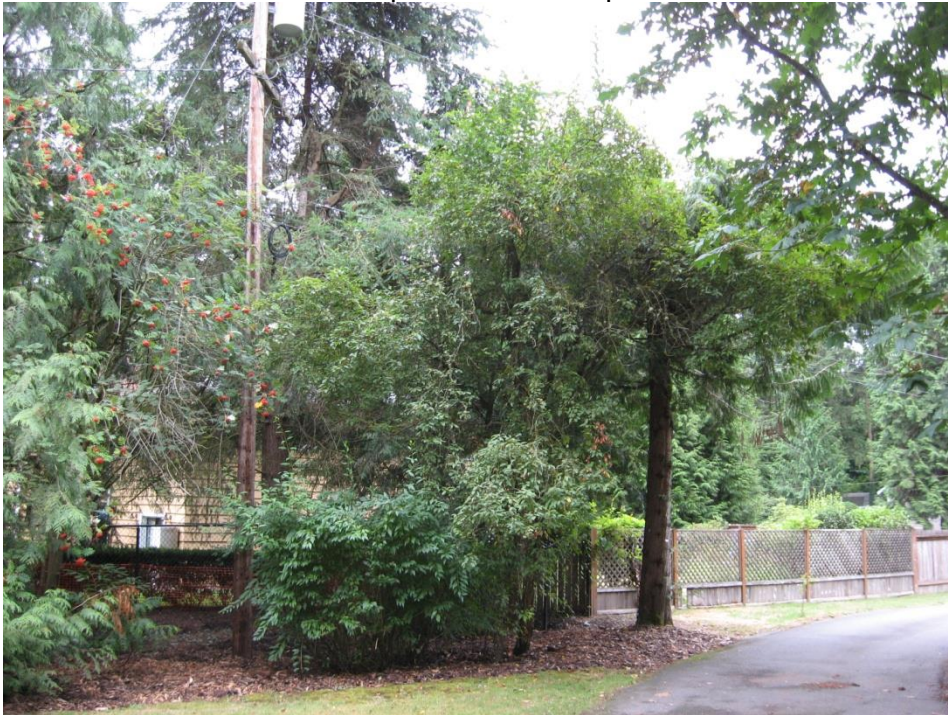
Trees #101 and #102 on east perimeter under power-lines

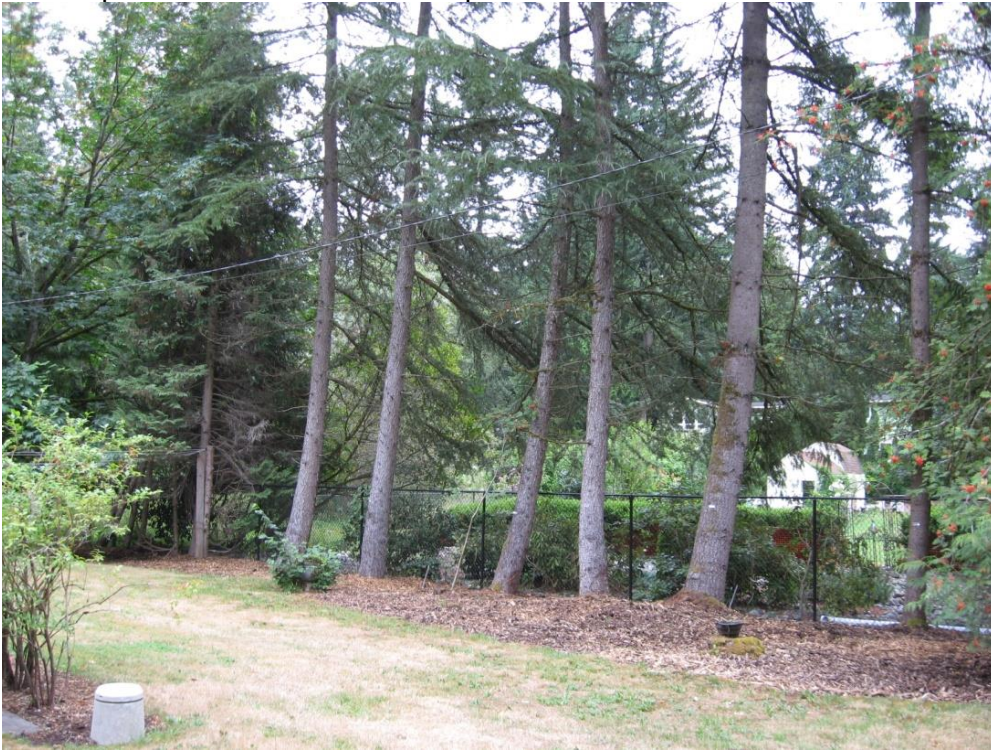
Row of planted Atlas cedar on east perimeter

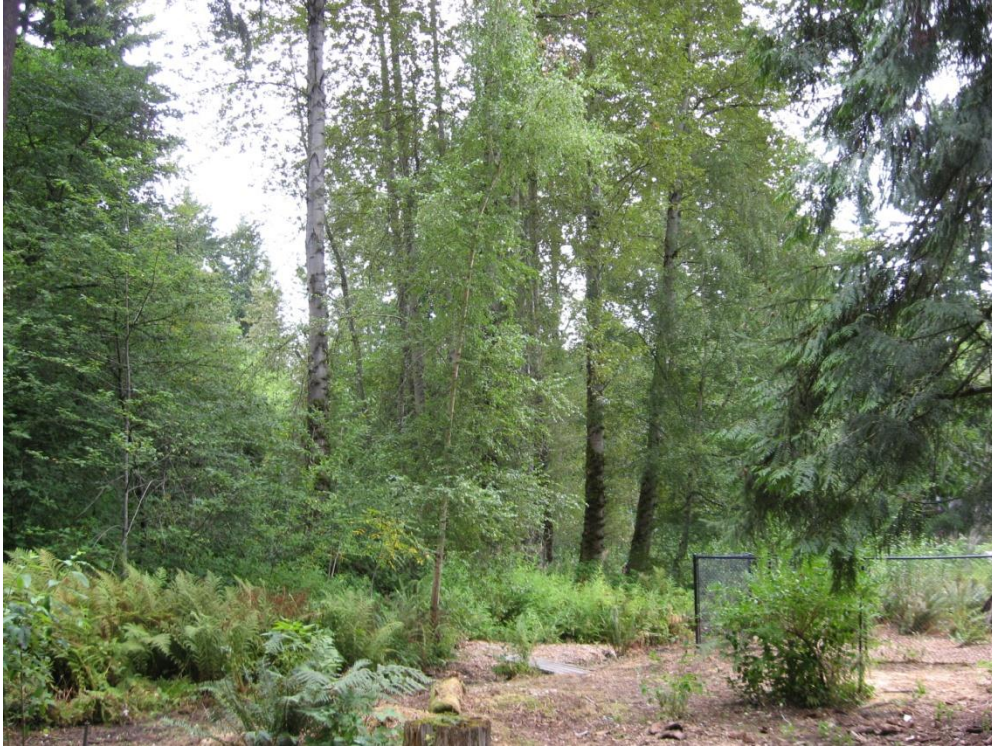
Northeast portion of property, neighboring cottonwood trees

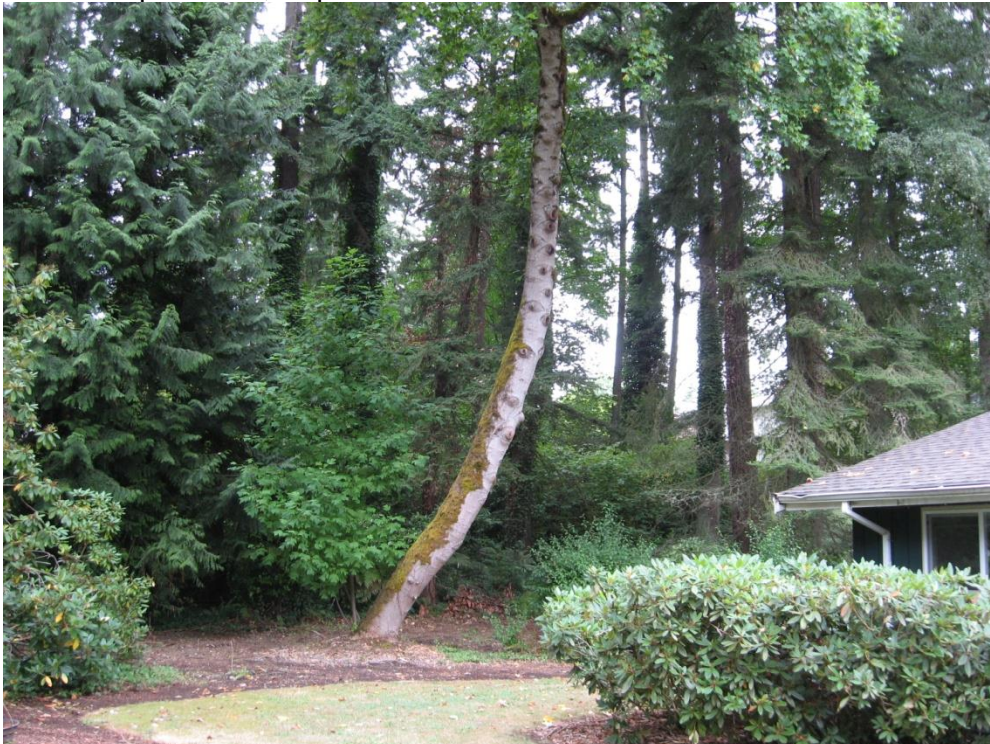
Northwest perimeter, tulip tree in front

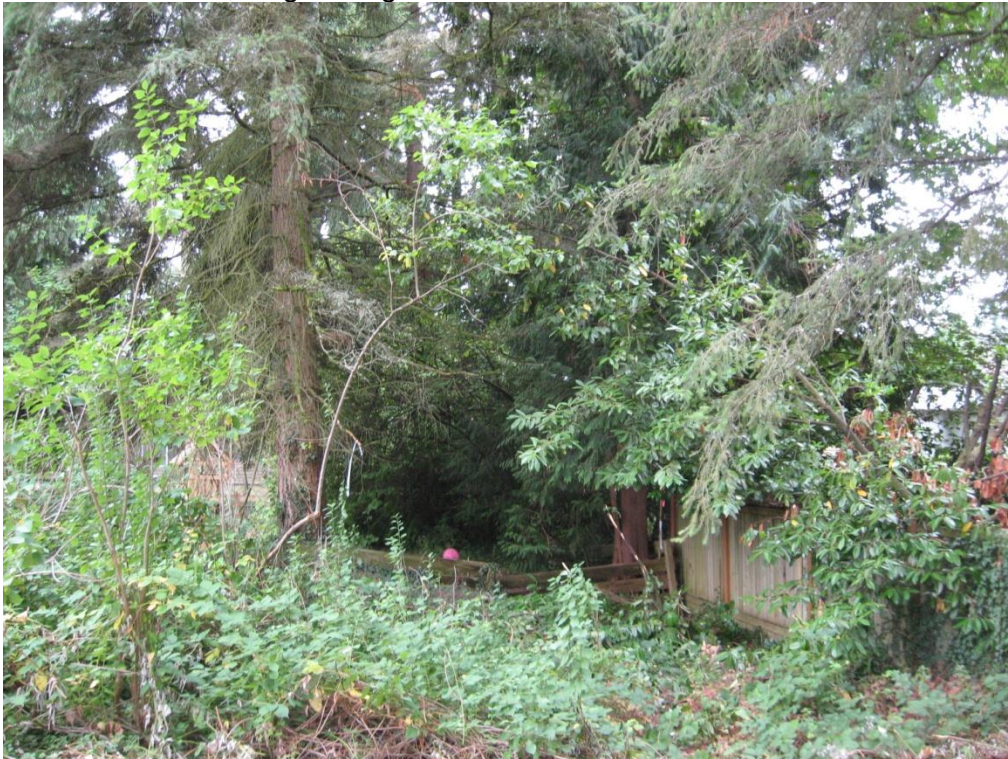
Southwest corner, neighboring trees
